### COOPER DRIVE PEDESTRIAN STUDY

**Research Report**  
KTC-06-14 / PTS01-06-1F

**COOPER DRIVE PEDESTRIAN STUDY**  
(Final Report)

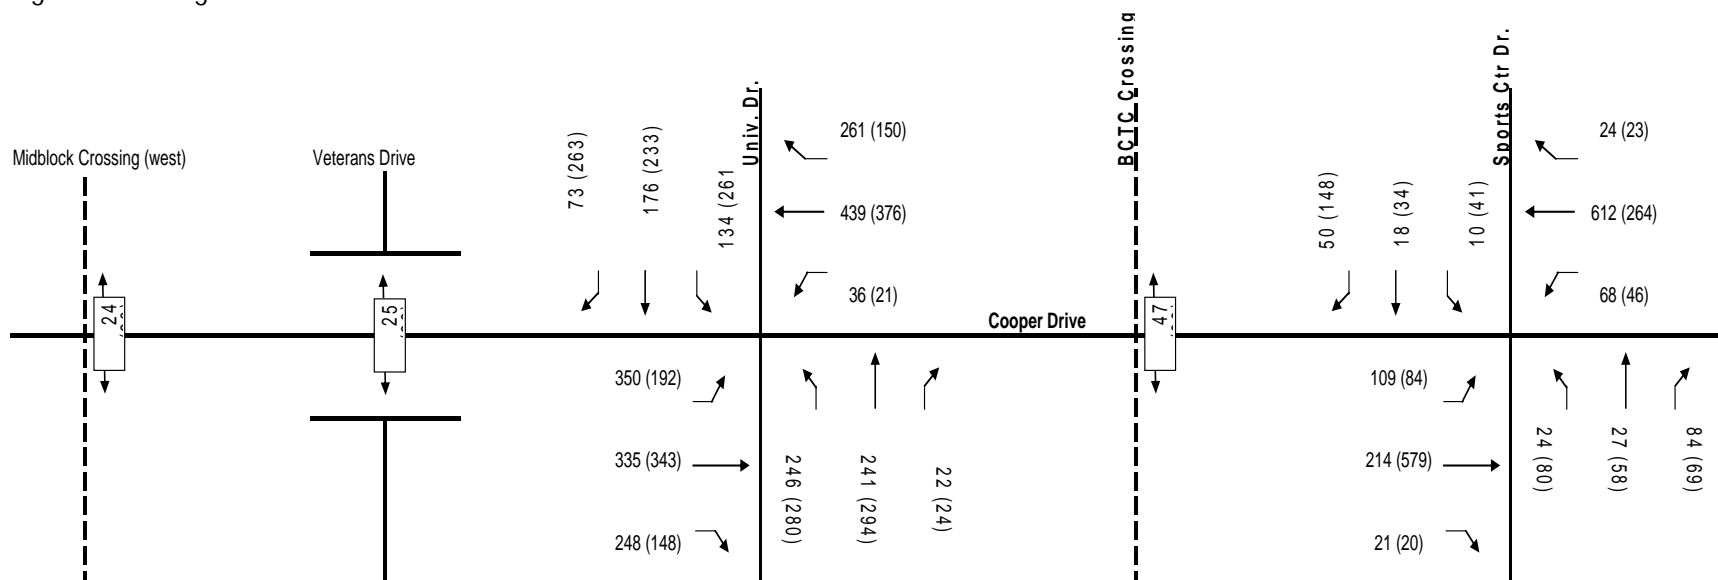
Figure 2: Turning Movement and Pedestrian Counts

Traffic data was collected in the form of manual turning movement counts at all signalized and unsignalized intersections and pedestrian counts were conducted at the mid-block crossings on the corridor. Data was collected December 4-6, 2005, during the fall semester. Turning movement counts were conducted during the AM and PM peak periods between 7:30 – 9:30 a.m. and 4:00- 6:00 p.m. Pedestrian counts were also conducted during these times, as well as during the mid-day peak period between 11:00 a.m. and 1:00 p.m. **Figure 2** summarizes the traffic data collected during this period.

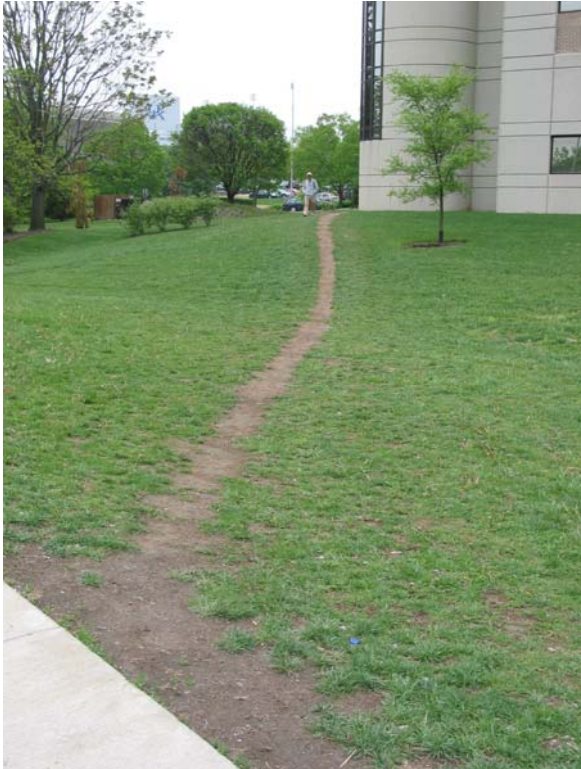
Figure 3: Worn path to Plant Sciences /Agricultural Engineering

The crossing between Plant Sciences and the parking lot at the Environmental Quality Management Center (EQMC) is an unmarked midblock crossing. Sidewalks are present on Cooper Drive; however, there is no direct connection for pedestrians who wish to cross Cooper towards the Agricultural Complex on the south side. The need for such a crossing is apparent from the well worn path that has been “created” from the high volume of pedestrians that use this crossing (**Figure 3**). The problem here is that pedestrians will not walk to the University/Cooper intersection to cross and then walk back to the Agricultural Complex. A sidewalk is present on the north side of Cooper Drive which connects to the EQMC and other area buildings.

A sidewalk on the south side of Cooper Drive should be constructed providing access to the Plant Sciences/Agricultural Engineering buildings, as the existing footpath indicates.

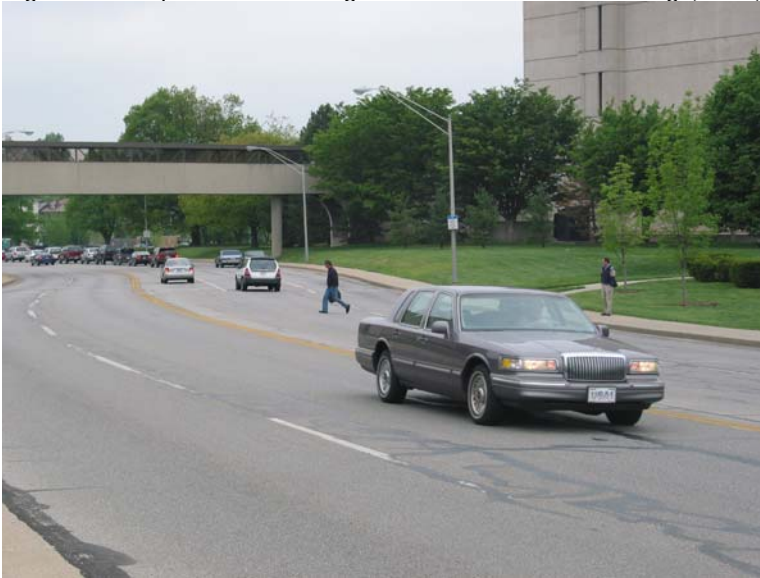
Figure 4: Cooper Drive looking North at Midblock Crossing (West)

This crossing creates an unsafe environment for pedestrians for several reasons. Traffic on Cooper Drive between University and Nicholashville is heavy and typically travels at higher speeds. In addition, this crossing occurs at the same place where vehicles negotiate a reverse horizontal curvature and several vehicles are changing lanes in anticipation of the turning movements at the downstream intersections. The five-lane cross section also increases the exposure for pedestrians as they must cross over 60 feet of high speed traffic. (See **Figure 4**)

The problems associated with this crossing are the roadway width and the speed of the traffic. The reduction of the total number of travel lanes on Cooper Drive and the provision of a median to allow pedestrian refuge will address these issues. Reducing the number of lanes will significantly improve safety for both pedestrians and vehicles. The exposure of pedestrians while crossing will be reduced, while at the same time the demands for lane choice and change decisions will be eliminated. The central median proposed at this location should be raised to provide a physical separation of pedestrian and vehicular traffic and improved channelization to vehicles. The crosswalk should be raised to allow for smooth crossing and better pedestrian visibility. As an interim solution, a wide flush median with transverse markings could be used.

It is also critical to increase the visibility of the crossing, alerting motorists to the potential presence of pedestrians. At a minimum advance pedestrian crossing signs should be installed on both approaches. A raised crosswalk at this location is also recommended to increase the visibility of pedestrians and reduce speeds through this congested area.

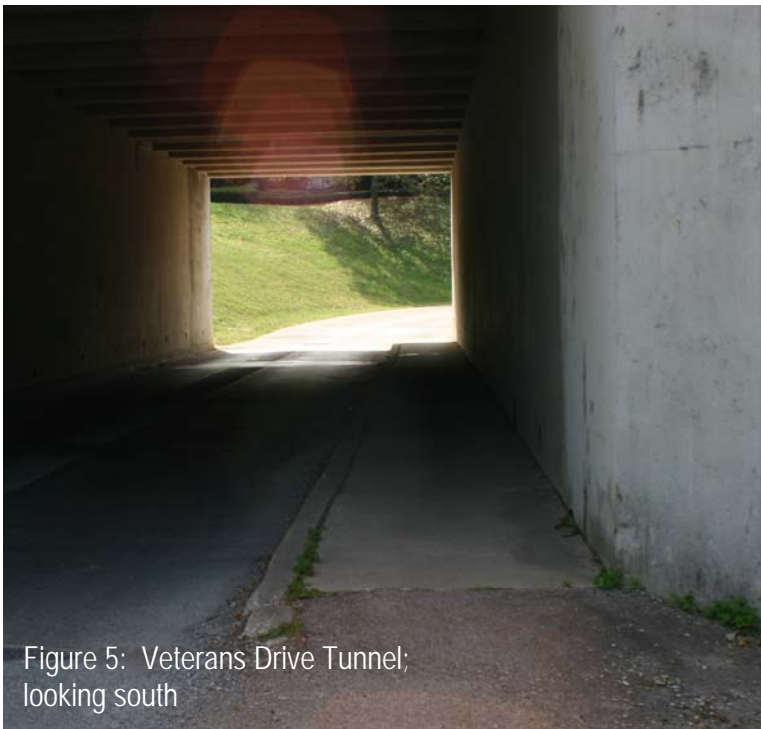
Figure 5: Veterans Drive Tunnel; looking south

Veterans drive is approximately 18-20 foot wide on both sides of the tunnel; however, no sidewalk or pedestrian facilities are provided. Through the tunnel Veterans Drive is 14.5 feet wide with a 5-foot sidewalk on the west side. (See **Figures 5**).

It is recommended that a pedestrian facility be provided throughout this entire section of Veterans Drive to separate pedestrian and vehicular traffic. The preferred placement of this facility would be on the east side of the street. Placing the sidewalk on this side will not interfere with the existing parking. At the same time, it will extend the existing sidewalk at Parking Structure 1 to the north and continue the sidewalk to the south, along well worn paths surrounding the Tobacco Research and Development Center. In order to reduce costs an extruded curb could be used, in conjunction with bollards to separate the pedestrian facility from the travel way. This alternative would require the removal of the existing sidewalk through the tunnel.

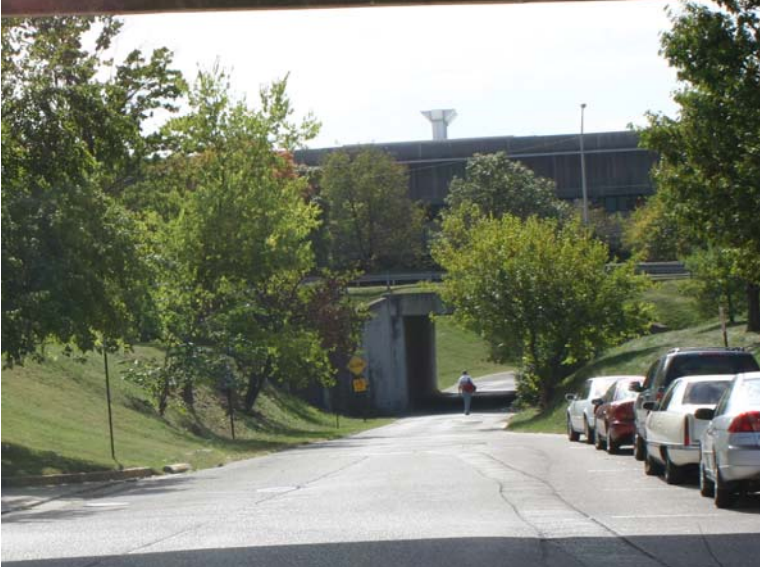
Figure 6: Veterans Drive N. of Tunnel; looking south

Problems with this location are the absence of any sidewalks connecting to the existing sidewalk in the tunnel and the sight obstructions at the south tunnel exit. Pedestrians typically walk on the east side of Veterans Drive, away from on-street parking, out of

the way of traffic. To enter the tunnel, pedestrians must cross the street to access the sidewalk through the tunnel (see **Figure 6**). South of the tunnel, most pedestrians again walk on the east side of street, due to the restricted sight distance caused by the embankment (see **Figure 7**). A footpath also exists in the form of steps up the steep slope on the southeast side of the tunnel; however, there is no clear origin or destination at the top of this path. (See **Figure 8**).

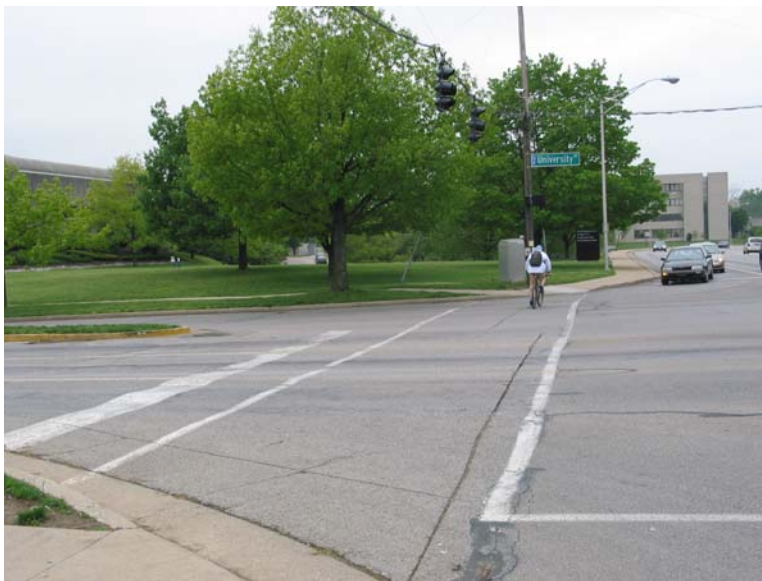
Figure 9: Crossing University Drive at Cooper Drive

experienced by both pedestrians and motorists lead to a competition for the same space which can create a hazardous situation for the pedestrian. In addition, pedestrians must cross five or six lanes of traffic on each leg of the intersection, without any protection or refuge from traffic. (See **Figure 9**)

As recommended above, the total number of lanes to be crossed should be reduced at this intersection, and a sufficient central median should be provided to allow for reduced exposure and a pedestrian refuge area, similar to that currently provided on the north leg of the intersection as shown in **Figure 14**.

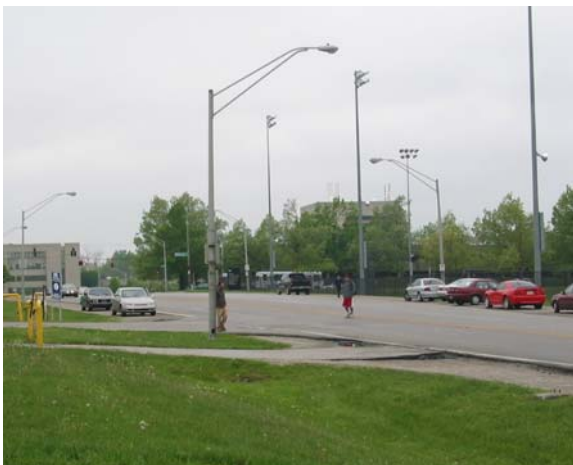
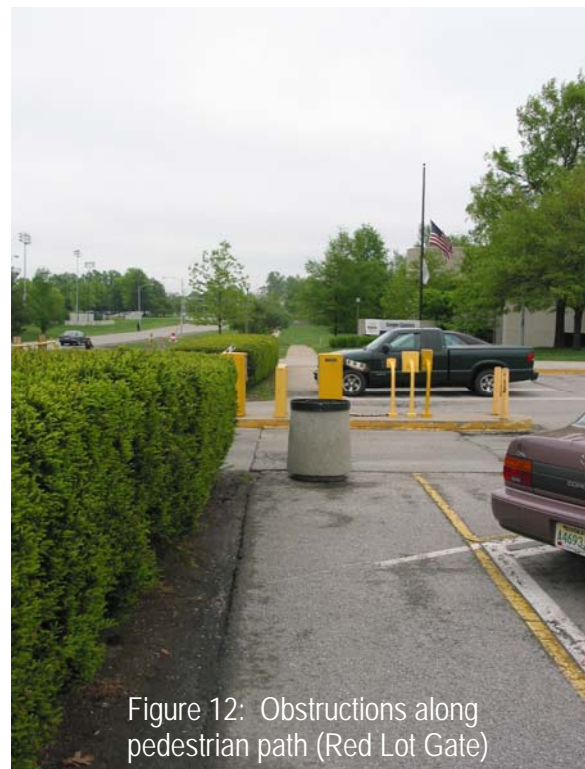
Figure 11: Pedestrians crossing at various points at Mid-block Crossing (East)

The eastern mid-block crossing connects the northern entrance of the BCTC Moloney Building on the south with the recreational fields and blue courts to the north. This crossing is shown in **Figure 10**. A hedge on the north side of the Red Lot restricts pedestrian activity and redirects it to this general area. However several breaks in the hedge currently exist along this area, creating several crossing points. (See **Figure 11**) In addition, the northern gate to the Red Lot obstructs the pedestrian path

to the designated crossing, as seen in Figure 12. This obstruction can force pedestrians to use the main vehicular gate to cross Cooper Drive. Another unsafe situation for pedestrians is the presence of turning vehicles in and out from the Red Lot, which often create conflict points and could become hazardous. There is also a vehicular access drive approximately 40 feet east of the Red Lot that provides opportunity for pedestrians to cross even though it is restricted to motor traffic,.

- 1) Relocate the entrance gate to the red lot closer approximately 6 feet closer to the Cooper Drive so that the gate arm is in line with the existing hedge, providing a more direct path for pedestrians.
- 2) Remove the existing vehicular access drive east of the Red Lot gate and continue the existing hedge line to the main sidewalk in front of BCTC.

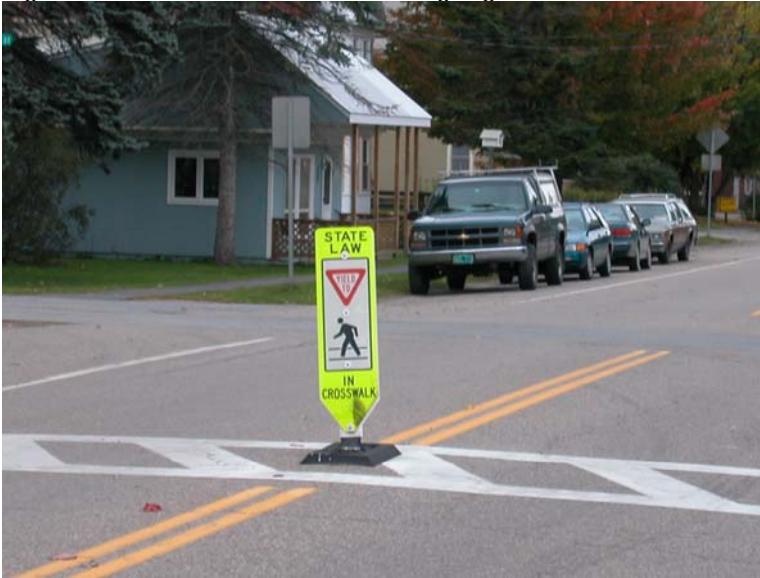
Figure 13: In-lane Pedestrian Crossing Sign

crosswalks for the traffic are often applied to both reduce speeds and make the crossing more obvious along with in-lane pedestrian crossing signs at the crossings (**Figure 13**). Raised crosswalks have also shown better visibility than on pavement crossings because they raise the pedestrian and place them at drivers' eye height (especially for larger vehicles). Such devices will be utilized in this study aiming to improve pedestrian visibility and safety.

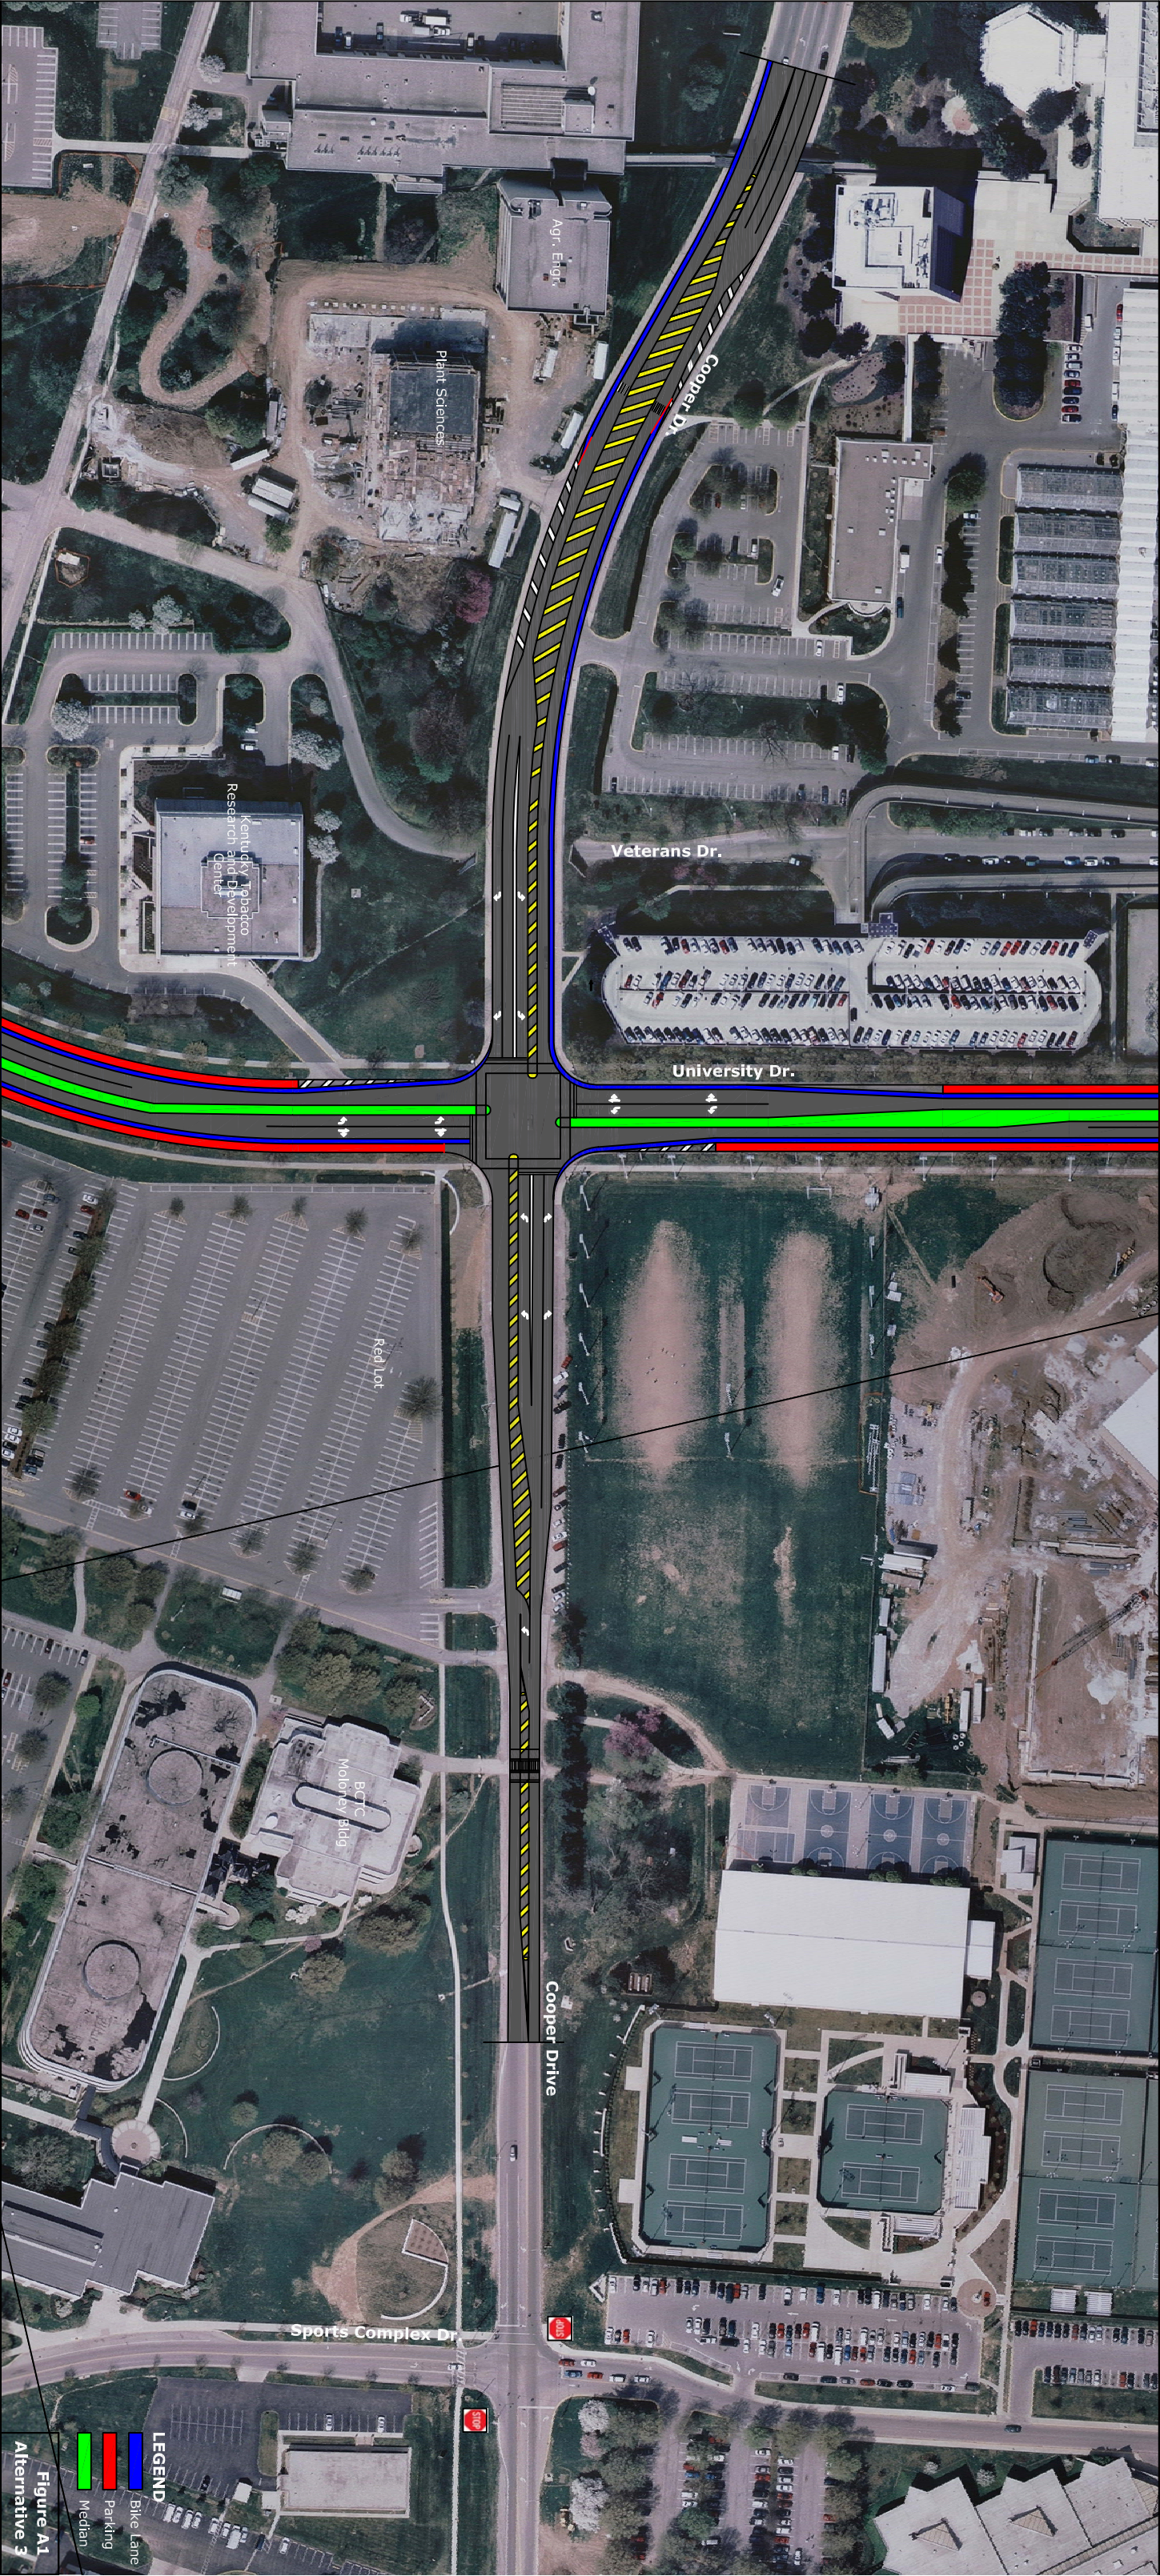
All short term improvements proposed under Alternative 2 are shown in **Figure A1**.

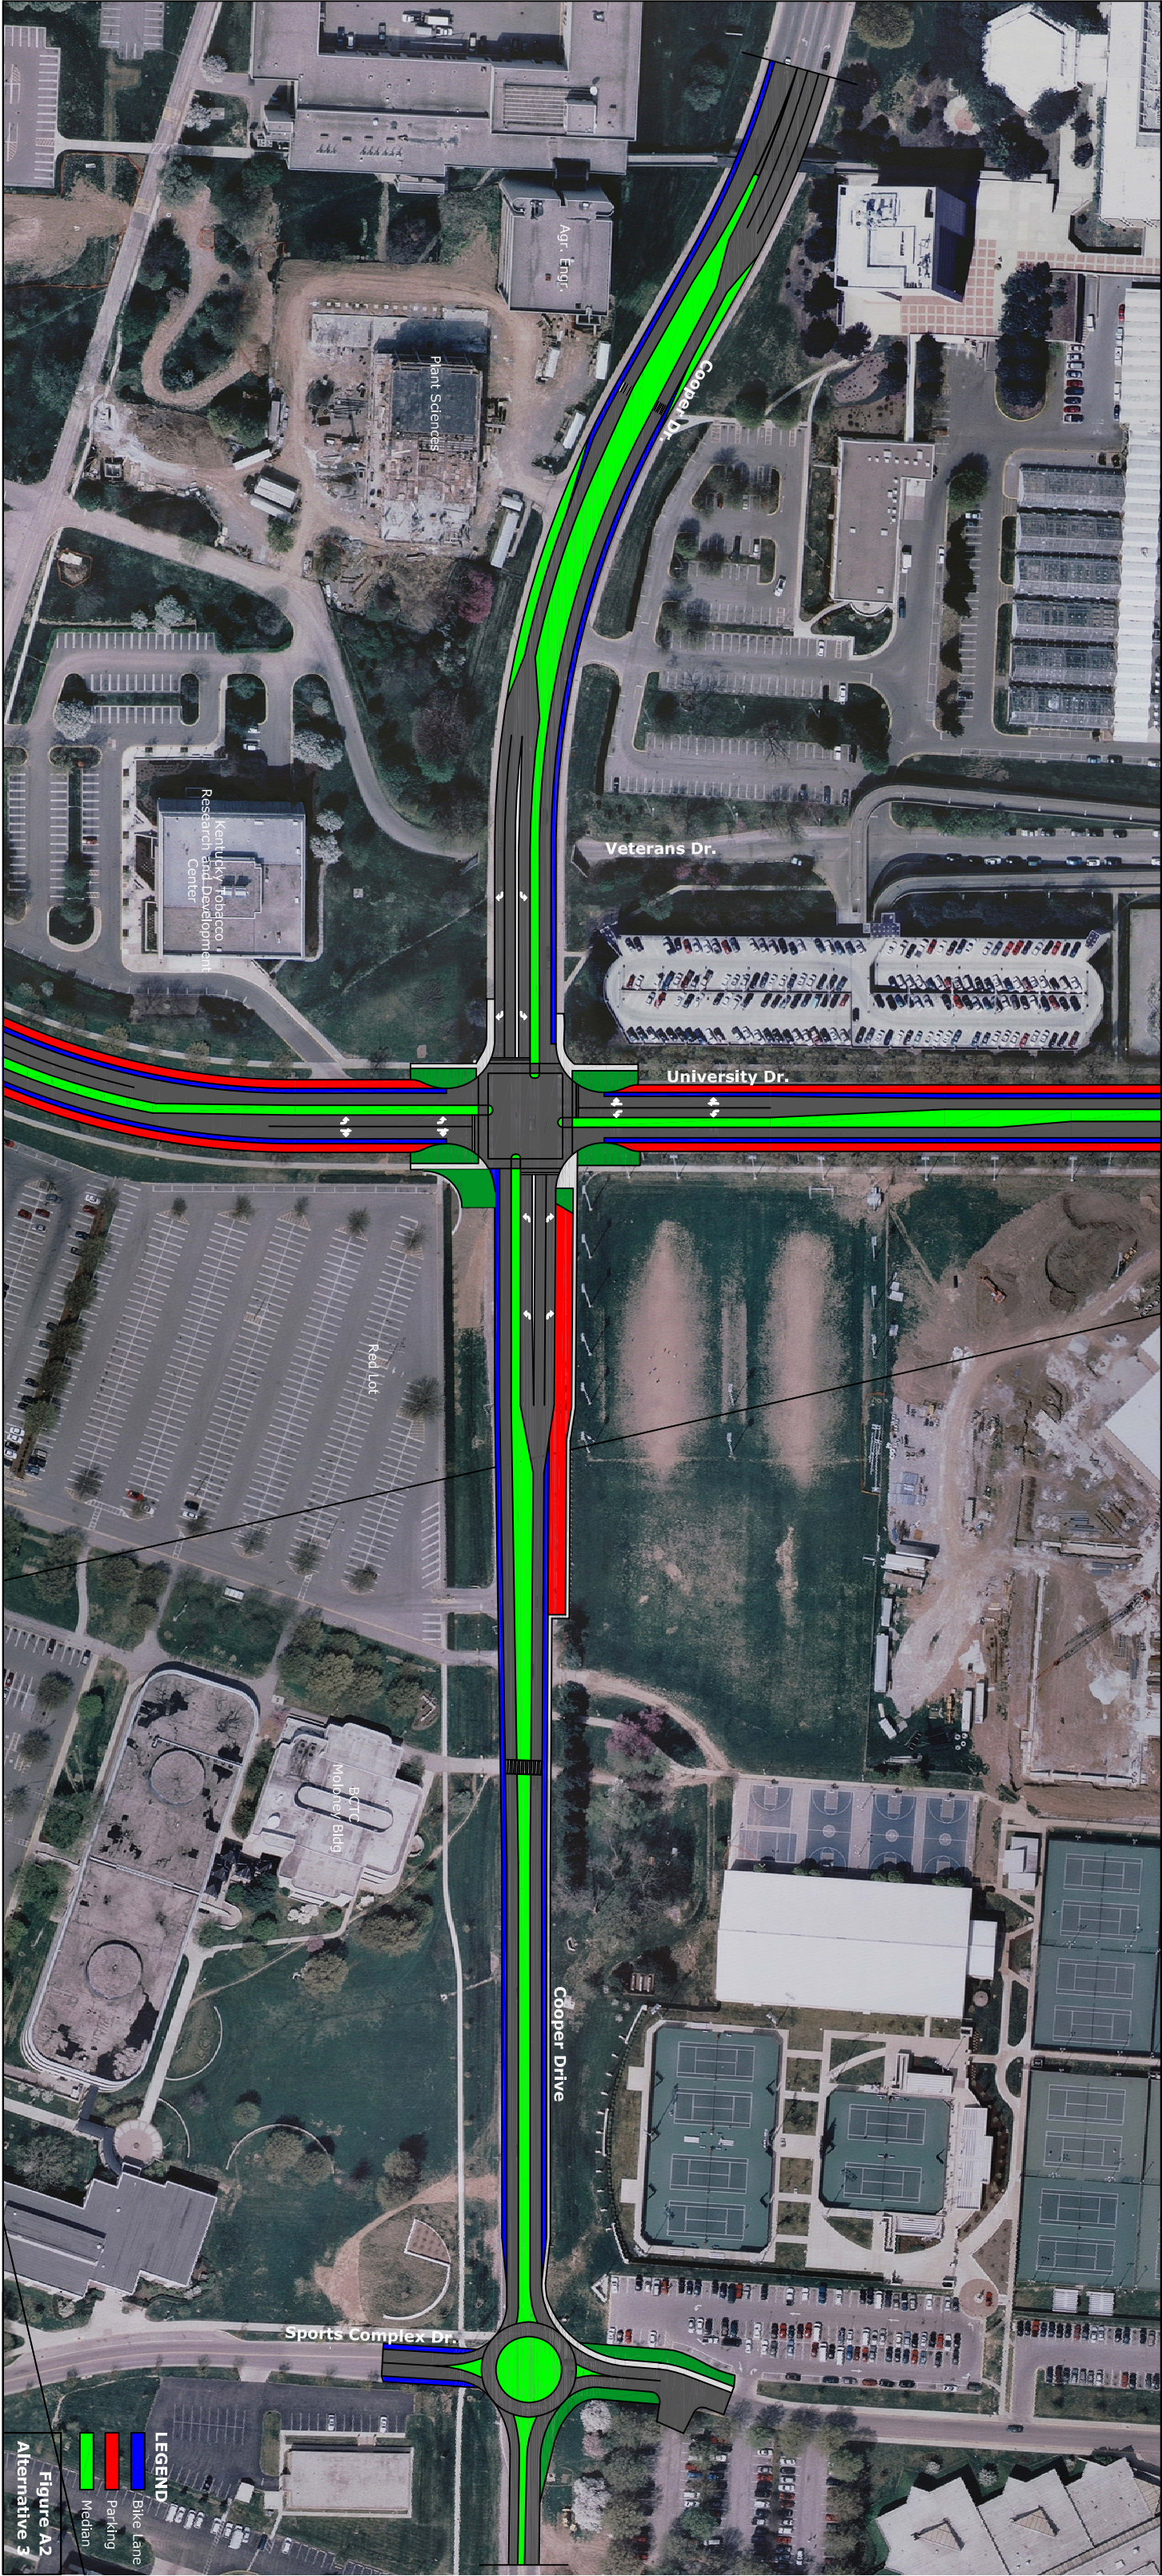
All long term improvements proposed under Alternative 3 are shown in **Figure A2**.
